The Application of Two-Dimensional X-ray Hot Stage in Flip Chip Package Failure Analysis

Yan Li, Rahul Panat, Bin Li, Rose Mulligan, Purushotham Kaushik Muthur Srinath, and Arun Raman

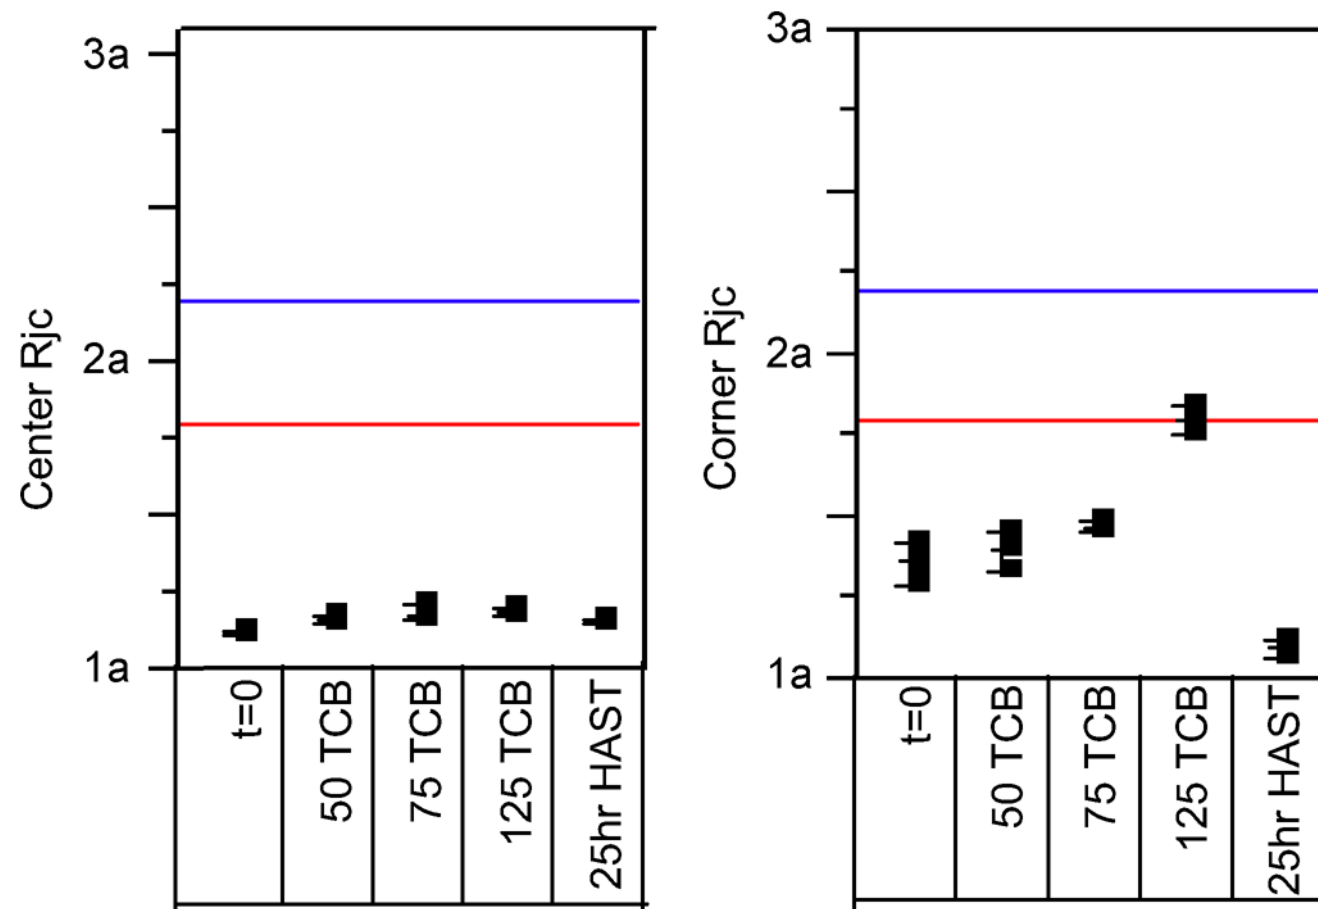
Fig. 2. TRES measurement shows corner Rjc degradation in the units with a NG-TIM material after 125-cycle TCB.

[3], [4]. One of the NG-TIMs developed so far was studied, which is a polymer solder hybrid material with both polymer and metal particles. The metal particles are low melting alloys, and the melting point is about 65°C. It was used as the TIM between the die and IHS for performance evaluation. TRES measurements show that the TRES at the corners (corner Rjc) is degraded after 125-thermal-cycle (TCB, −55°C to 125°C) stress. The corner Rjc is good after a 25-h unbiased highly accelerated stress test (UHAST, 130°C, 85% relative humidity) (shown in Fig. 2). C-mode scanning acoustic microscope (CSAM) images (see Fig. 3(a) and (b)) at the lid-to-TIM interface were taken for units after the 125-cycle TCB and those after the 25-h UHAST stress. The metal particles in this NG-TIM material show up as dark contrast in the CSAM images. For both units, the distribution of the metal particles at the die corners is much lower than that at the die center. Compared with the unit after the 25-h UHAST, the unit after the 125-cycle TCB stress has even less distribution of metal particles at the corners, and the size of the particles at the corners is much larger, as shown in Fig. 3(d) and (e). At room temperature, when the material was applied to the die, the distribution of the metal particles was uniform. After the sealant cure (one of the processes during the IHS attach process with high temperature), the CSAM images of the unit before any reliability stress indicate that the metal particle distribution is similar with that in the unit after the UHAST, as shown in Fig. 3(c). To understand the reasons behind the change in the metal particle distribution in this NG-TIM material after the unit went through a high-temperature process, a 2-D X-ray hot stage was used to study its behavior at elevated temperatures.

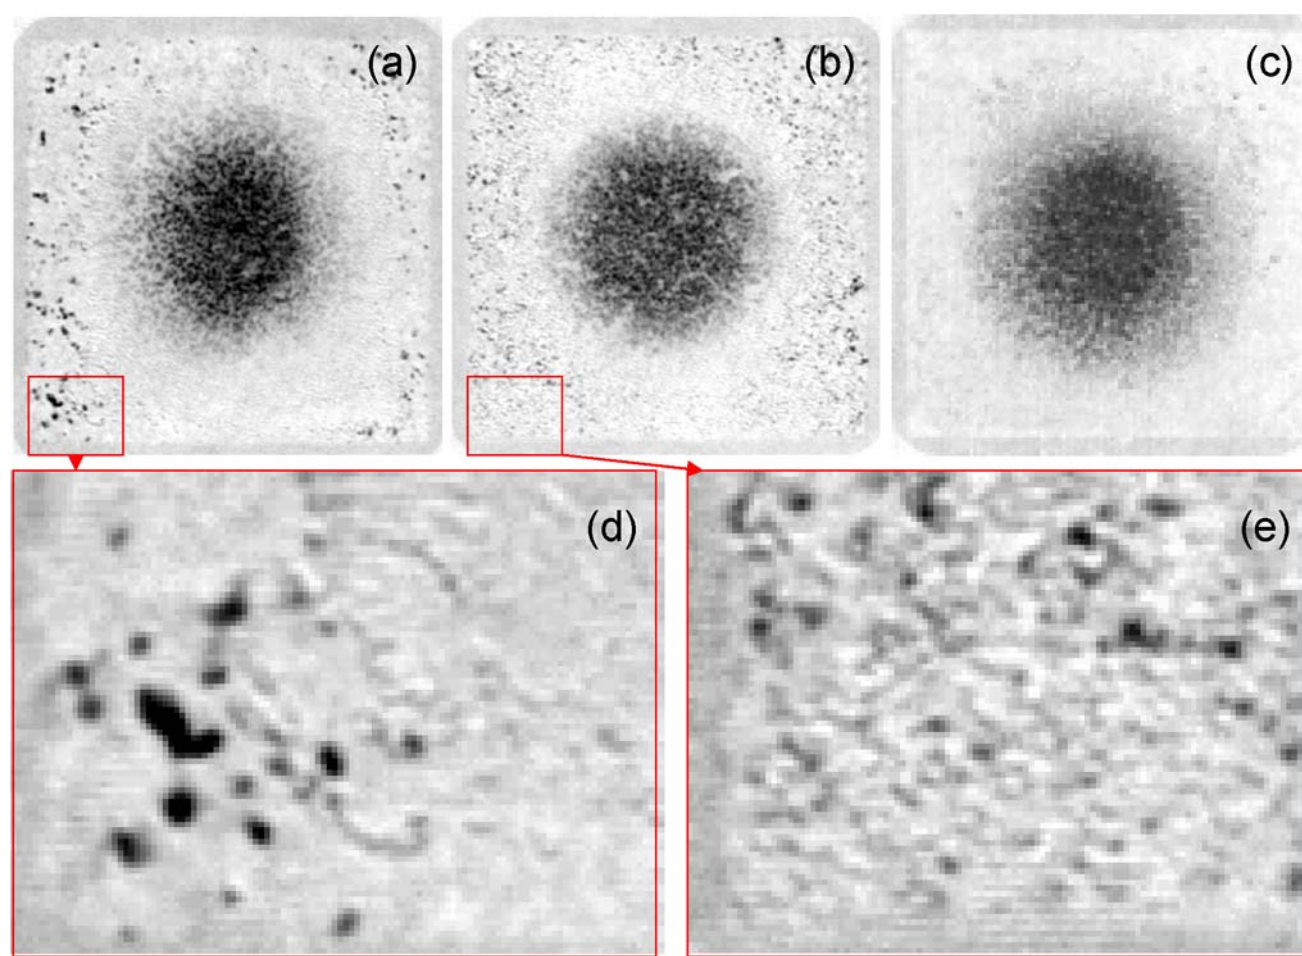
Fig. 3. CSAM images at lid-to-TIM interface from a unit after 125-cycle TCB (a); a unit after 25-h UHAST stress (b); and an unstressed unit (c). CSAM images on the die corners of a unit after 125-cycle TCB and a unit after 25-h UHAST stress are shown in (d) and (e), respectively. Dark contrast in the image shows the metal particles in that NG-TIM material.

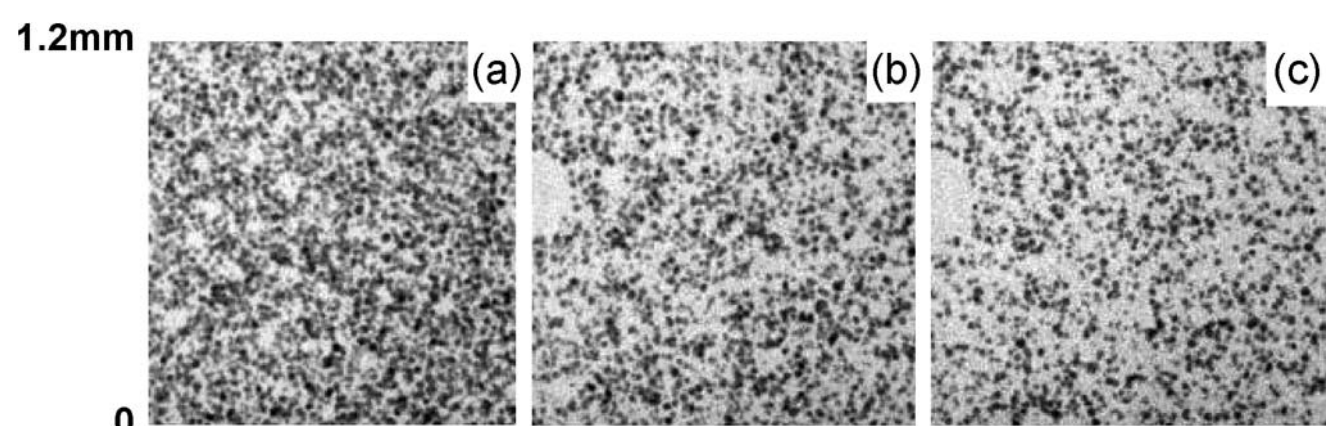
Fig. 5. *In situ* 2-D X-ray study of a NG-TIM material at 125°C: 2-D X-ray image taken (a) at room temperature, (b) at 125°C for 10 s, and (c) at 125°C for 15 min.

The dark contrast in the 2-D X-ray images shown in Figs. 5 and 6 indicates the metal particles inside the NG-TIM material. At room temperature, the distribution of the metal particles

was uniform. The metal particles started moving around in the polymer matrix when the temperature reached around 65°C. The volume of the material expands, and the density of the metal particles became smaller and smaller as the temperature increased. Larger particles and areas without metal particles were formed. Larger movement of the metal particles happened when the temperature was about 220°C. The particle size and the area without any metal particles became even bigger.

Based on the *in situ* 2-D X-ray study of the material, we can have the following hypothesis for the corner TRES degradation. At room temperature, when this NG-TIM was applied on the die, the distribution of the metal particles was uniform. When the unit was heated up during process and reliability stress testing, the NG-TIM material tends to behave like a viscous fluid, and the mobility of low melting metal particles increases once the temperature reaches 65°C. Because of the dynamic warpage of the package, the convex shape around the die area gradually changes to a concave shape. The viscous fluid then tends to flow toward the die center area as more space between the IHS and the die would appear at the die center. During the movement, the melting metal particles could coalesce to form bigger particles. After the 125-cycle TCB stress, the unit is heated up 125 times, and more and more metal particles at the die corners move to the die center area, which may lead to low metal particle coverage at the die corners and cause higher corner TRES. To fix this problem, modification on this NG-TIM matrix polymer is needed so that the metal particles would not move around at elevated temperatures.

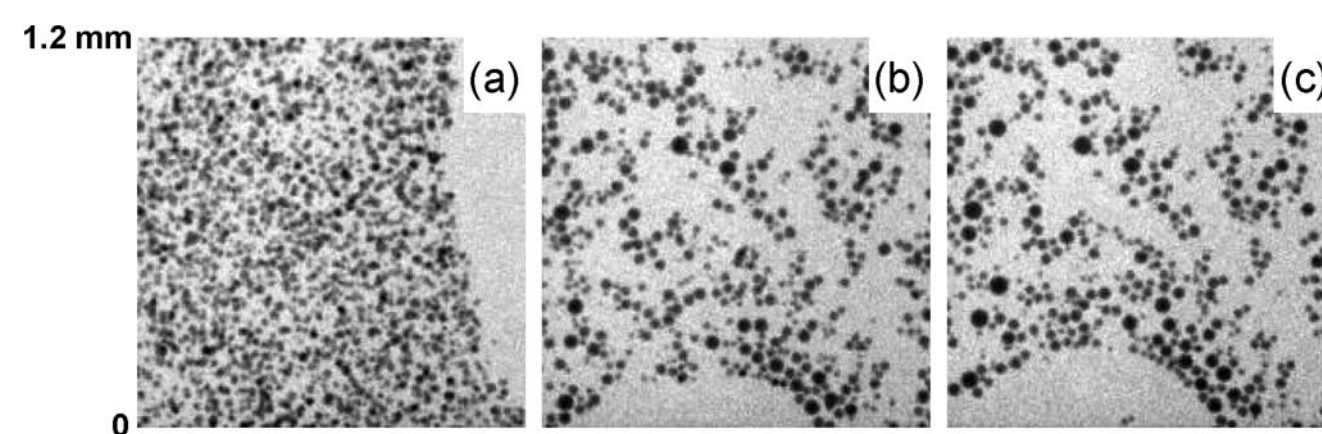
Fig. 6. *In situ* 2-D X-ray study of a NG-TIM material at 260°C: 2-D X-ray images were taken (a) at room temperature, (b) at 260°C for 10 s, and (c) at 260°C for 15 min.

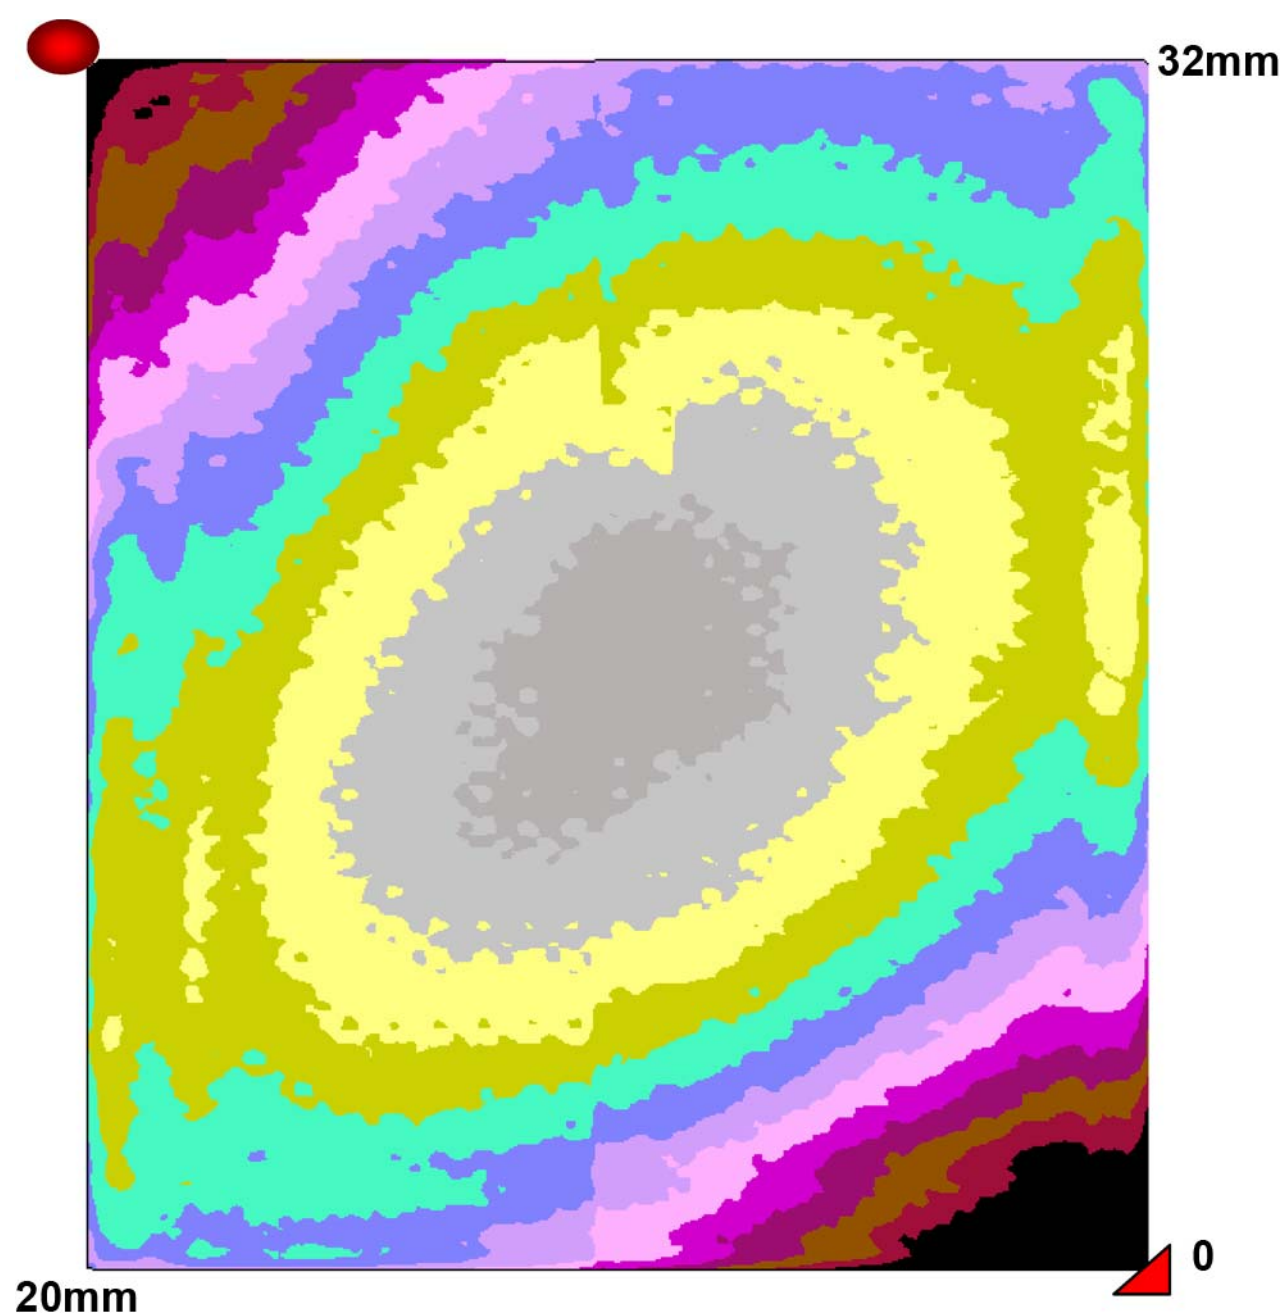
Fig. 7. Typical contour plot of the substrates selected for the C4 solder joint bridging experiment. The plot shows fixed increment contours on the substrate in the die attach area (before die attach). The shape is spherical concave, and the darker the color, the higher the contour elevation. The highest corner is labeled as red triangle. The solder bump bridging corner is usually the second highest corner, labeled as a red dot.

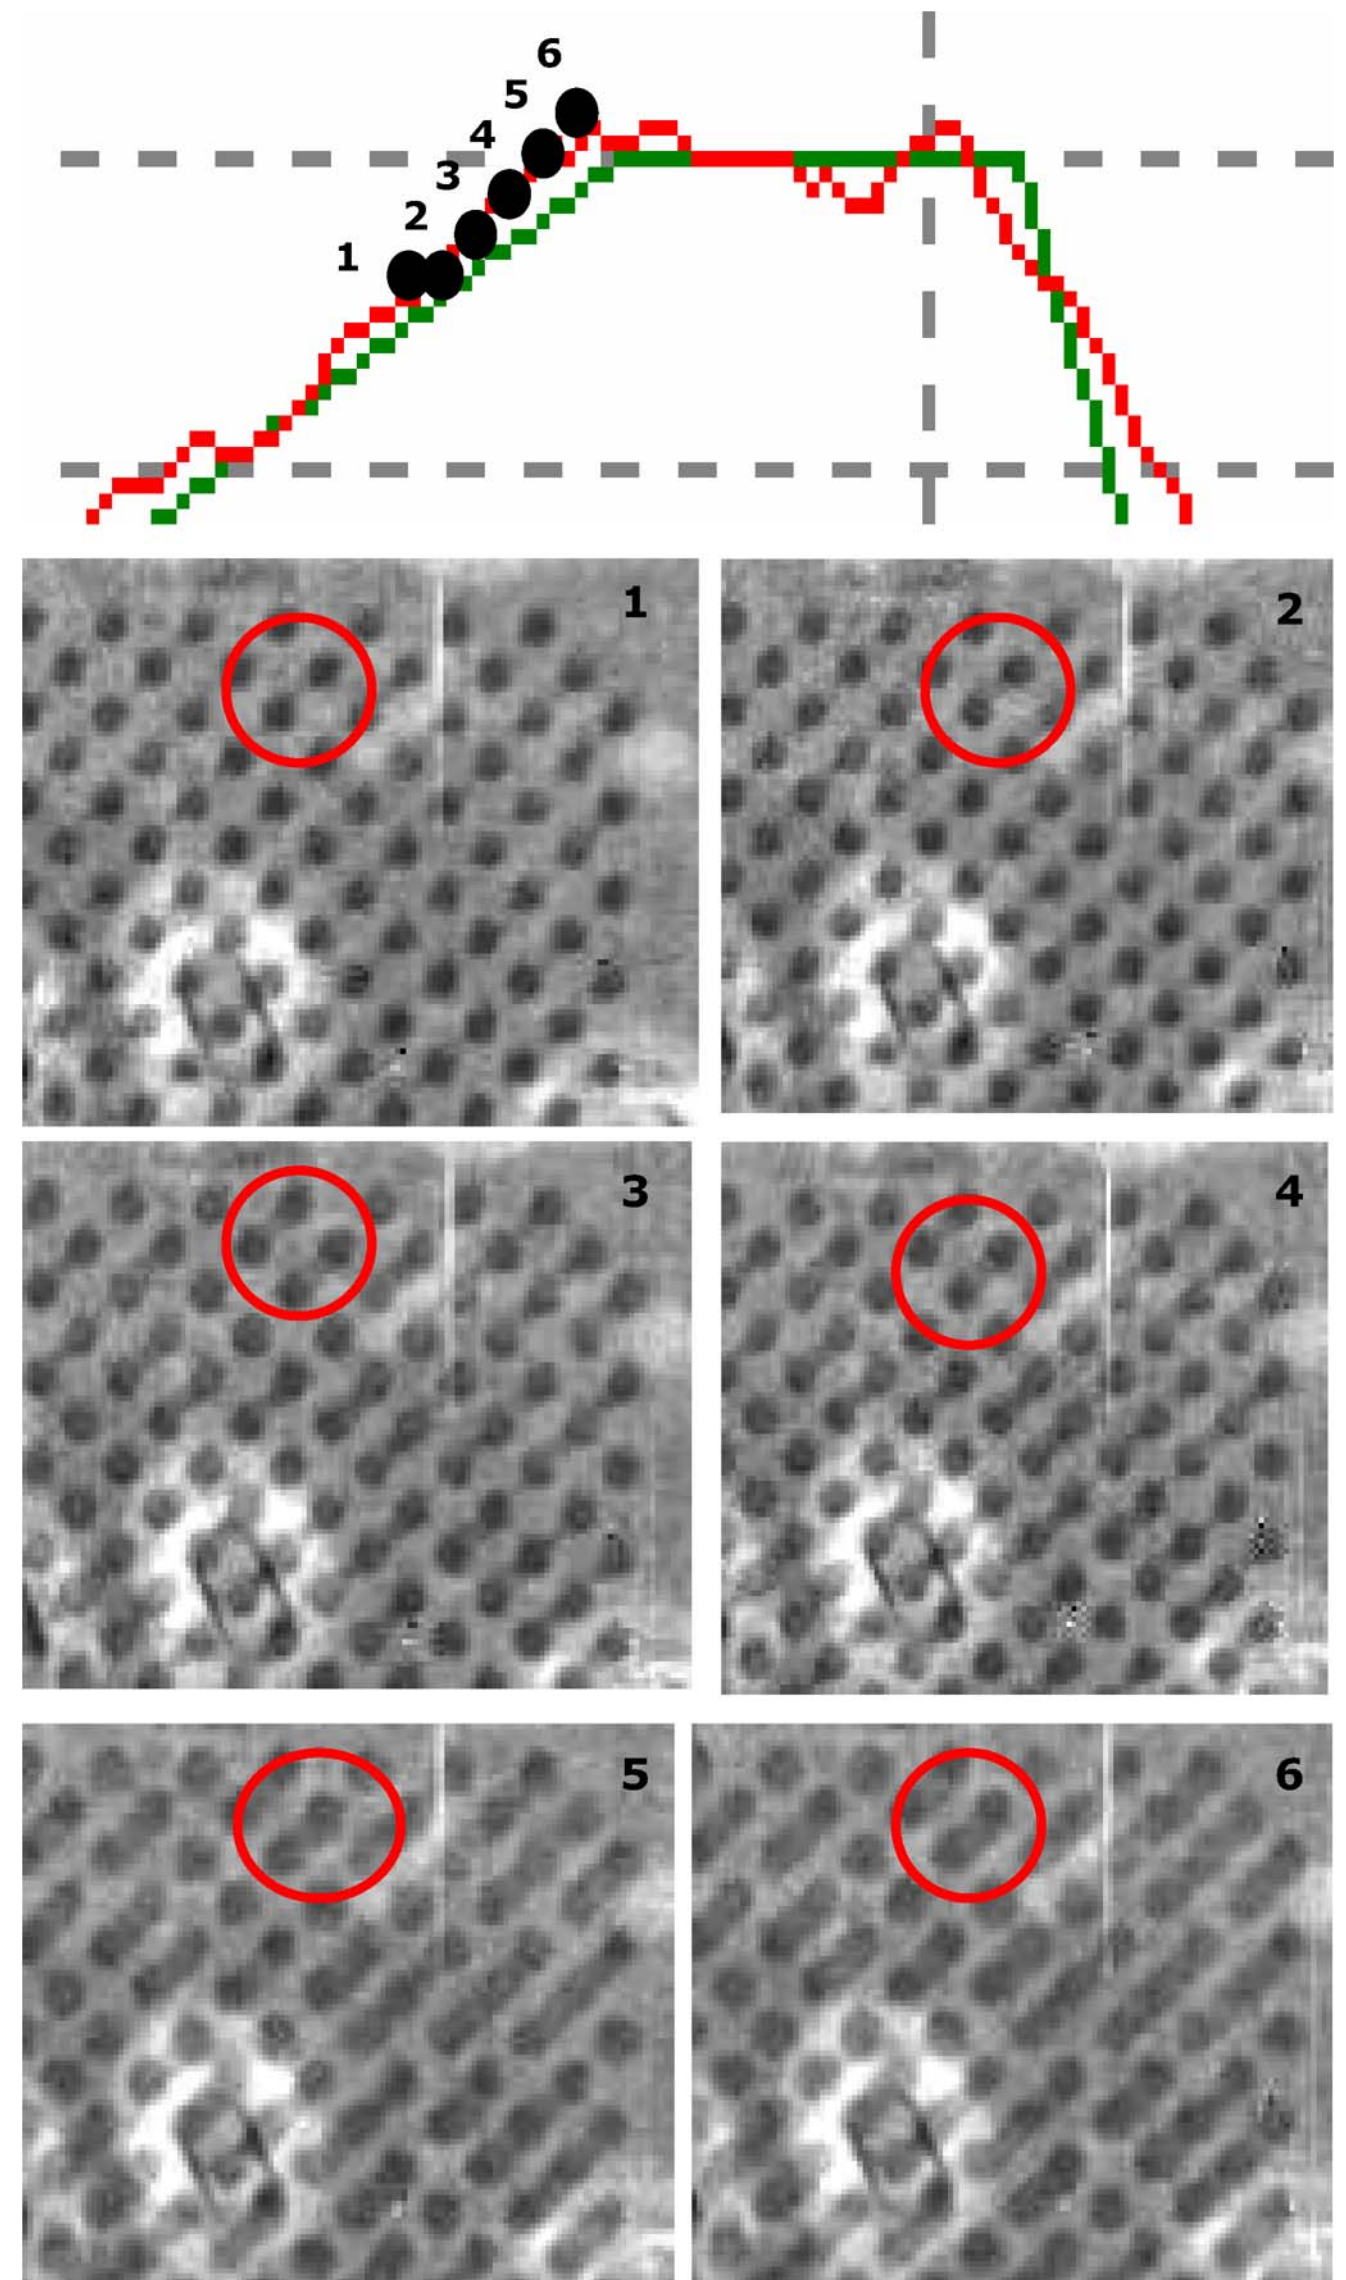
The X-ray images taken before heating up the hot stage show that there was no die misalignment on the units. Fig. 8 shows the heating profile as well as the X-ray images of the second highest corner (labeled as red dot in Fig. 7) taken at different locations of the heating profile. There is no significant change on the solder balls until the temperature reaches above the melting temperature of the lead-free solder. Solder joint bridging happened thereafter within 6 s. The X-ray images labeled 1–6 show how the solder bump bridging happened during 6 s. At first, a tiny solder line formed between two diagonally adjacent solder bumps (1 in Fig. 8). The width of the solder lines grew larger and larger until it became the same as the diameter of the solder bumps (2–6 in Fig. 8). No significant changes were observed on the solder bumps after 6 s.

Fig. 8. *In situ* 2-D X-ray study of C4 solder joint bridging due to incoming die attach area substrate warpage. Solder joint bridging happened within 6 s when the temperature reaches the melting temperature of the Pb-free solder. The green line is the programmed temperature profile, while the red line shows the real temperature profile.

is dragged toward that corner and cause solder bump bridging at the highest corner. Limits of die area substrate warpage need to be set in order to avoid C4 solder bump bridging during the chip attach solder reflow process.

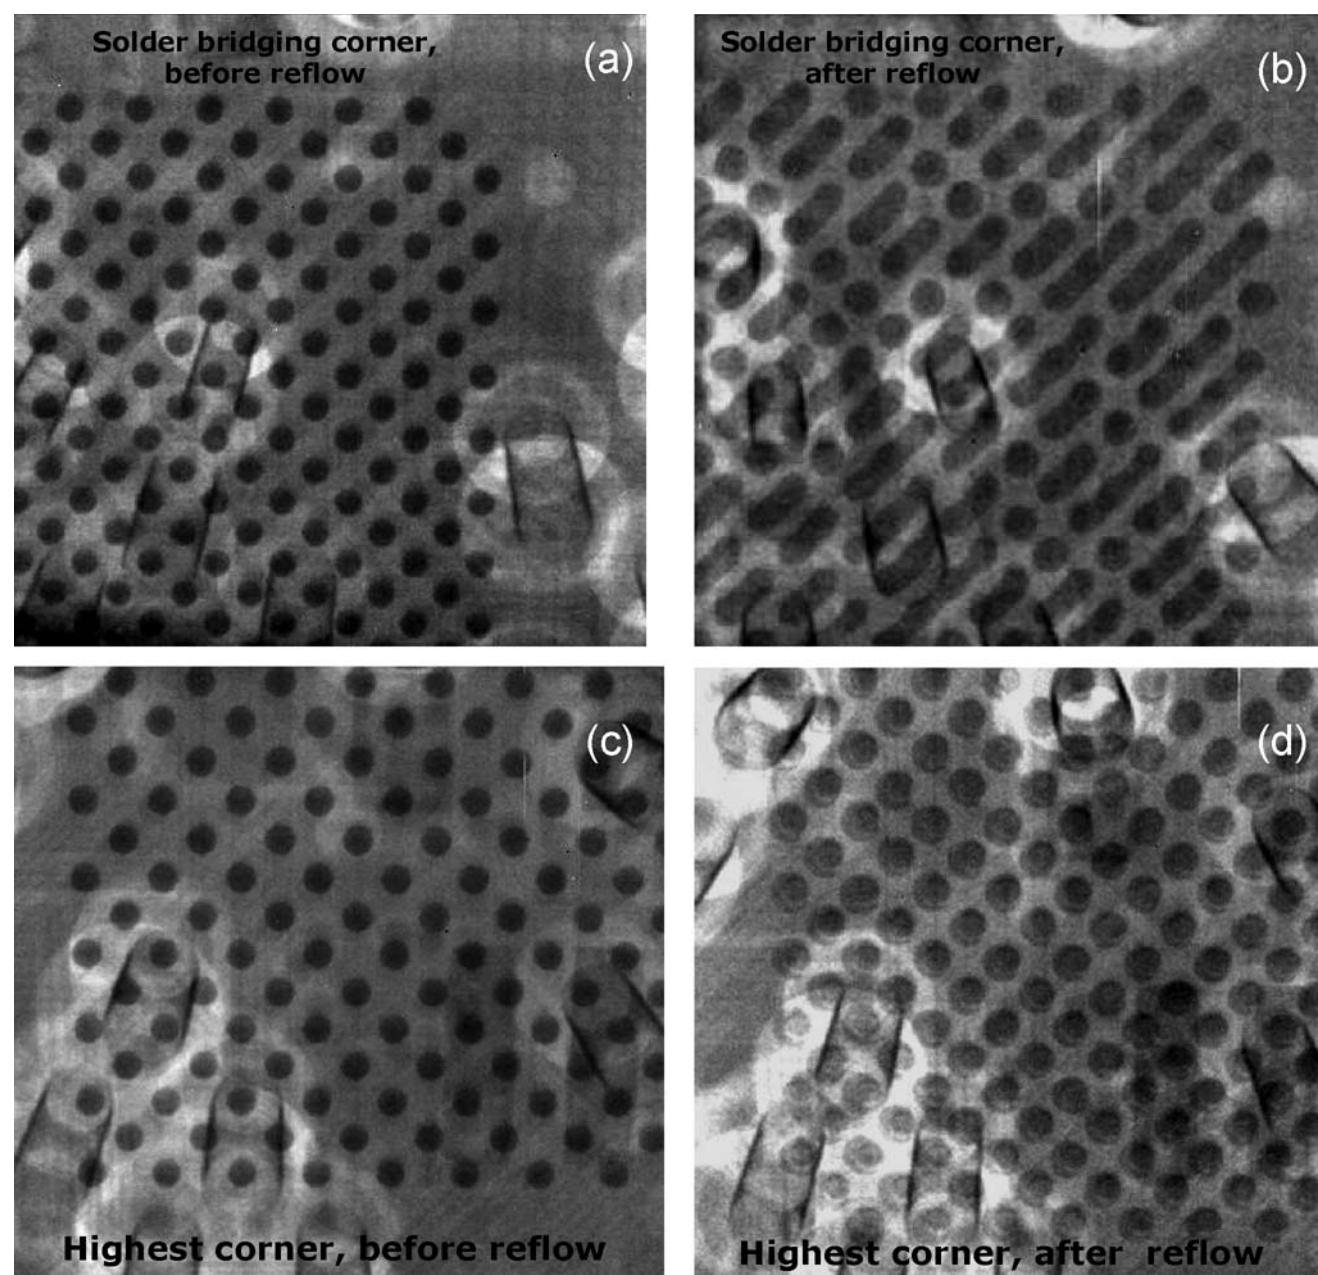
For most cases, the solder bump bridging only happened at the second highest corner (labeled as red dot in Fig. 7). For all the other three corners, we did not observe any solder bump bridging. Fig. 9 shows the 2-D X-ray images of the highest corner and the solder bridging corner taken before and after the solder reflow. For other corners, no significant change was observed. In Fig. 9(d), we can see some gray dark circles around the solder bumps, which may indicate the bumps on the die. Considering the fact that there was no die misalignment before the reflow (shown in Fig. 9(c)), we can conclude that the die shifted toward the highest corner during the reflow.

due to incoming die attach area substrate warpage. Because of the large warpage of the substrate, the gap between the solder ball on the substrate and the die bump is the smallest for the highest corner. At the highest corner, the solder may wet the die bump a little earlier than the other three corners when the temperature reaches the melting temperature of the solder. Once the solder wets the die bump at the highest corner, the die will be pulled down and dragged toward that corner. The movement of the die while the solder is wetting the second highest corner may cause the solder bump bridging. We also found that the bump layout may also influence the result. If the warpage difference is small between the highest and the second highest corner and the second highest corner has a corner bump while the highest corner does not, solder bump bridging will happen at the highest corner. The solder may wet the corner bump at the second highest corner a little earlier, and the die

Fig. 9. Two-dimensional X-ray images of the solder bridging corner taken (a) before reflow and (b) after reflow. Two-dimensional X-ray images of the highest corner taken (c) before reflow and (d) after reflow.

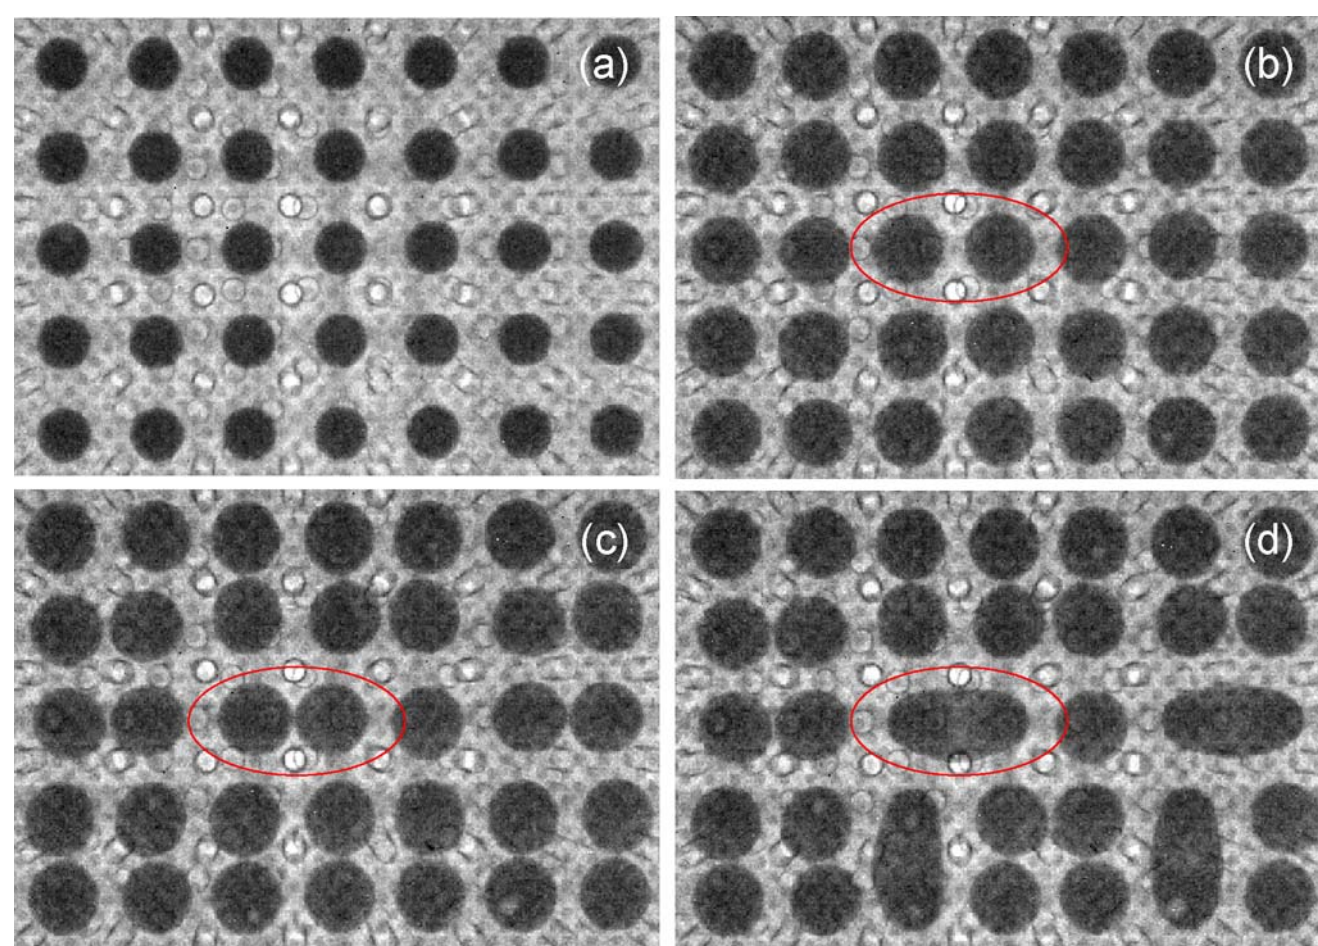
Fig. 10. *In situ* 2-D X-ray images showing formation of solder bridging at center area of a large package with IHS in SMT solder reflow. Two-dimensional X-ray images taken (a) before reflow and (b)–(d) during reflow. BGA solder joint bridging happened in the center of the package. The center solder bumps move around and touch the adjacent solder bumps and caused the bridging.

The 2-D X-ray image taken before the SMT reflow on the hot stage shown in Fig. 10(a) indicates that there was no package-to-board misalignment. Once the temperature reached the melting temperature of the lead-free solder, the center solder balls collapsed heavily, and the molten solder bulged out from the board pads, leading to a reduction of the joint gap distance (shown in Fig. 10(b)). Interestingly, it was observed that the molten solder moved around pads, and for some of the joints, the molten solder moved toward each other, resulting in a further reduction of the joint gap distance, which is shown in Fig. 10(c). When two adjacent molten solder balls are in contact with each other, a bridged joint is formed, as shown in Fig. 10(d).

Based on the *in situ* 2-D X-ray data, we come up with the following hypothesis for BGA solder joint bridging in large packages. As shown in Fig. 11, the weight of a large package with IHS is relatively heavy, sometimes around 40 g. Considering the dynamic warpage of the package, there will be a significant amount of force applied on the board pads in the center of the package during SMT reflow. Solder balls in the center area undergo a big collapse and bulge out from the pad periphery, which leads to a reduction in the solder joint gap distance. As two adjacent molten solder balls move and are in contact with each other, a bridged joint forms to reduce the total surface energy of the molten solder. The *in situ* 2-D X-ray imaging results clearly indicate that the failure mechanism of solder joint bridging in large packages with IHS is due to a large force applied on the center pad in the reflow, which is induced by the package weight and dynamic warpage as well as the dynamic motion of the solder in time at liquidus. To limit the BGA solder joint bridging, board pads need to be designed to keep solder balls from moving around.
